SPECIAL PUBLICATION 116

THE NORTHRIDGE, CALIFORNIA, EARTHQUAKE OF 17 JANUARY 1994

DIVISION OF
MINES AND GEOLOGY

**The Northridge, California, Earthquake
of 17 January 1994**

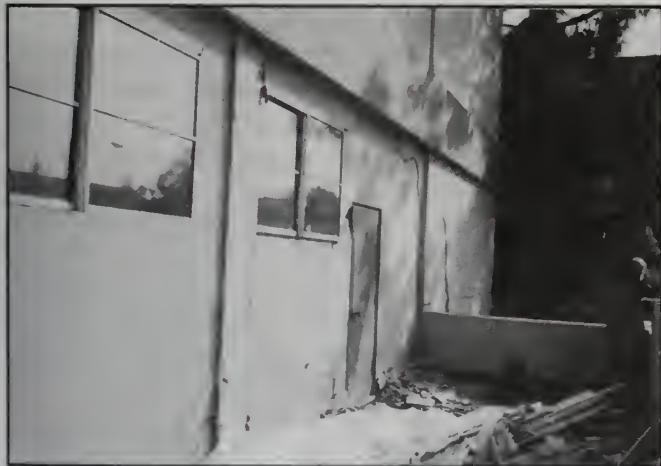
Hospital Tower. Four-story steel frame and concrete shear wall building. Damage to shear wall (Photo 10), to elevator counter weights, electrical equipment, and water pipes. Some interior water damage.

Photo 10. Medical Center of North Hollywood, showing extensive cracking of shear wall at the southwest corner of the building where a window was added in a shear wall.

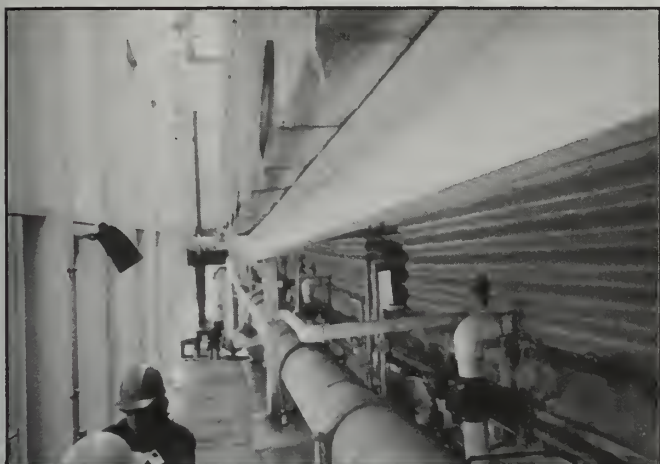
Photo 11. St. Johns Hospital, Santa Monica, showing damage to the roof-mounted cooling tower due to failure of beam support at the columns.

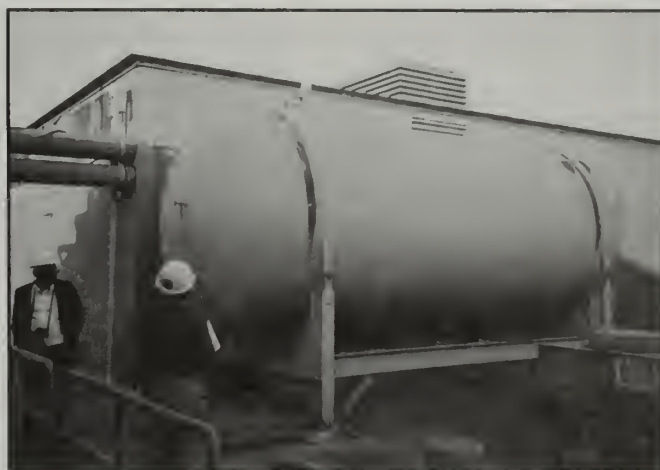
Photo 12. Cedar Sinai Medical Center, Los Angeles, showing a storage tank that shifted under restraining straps due to lack of positive tank anchorage in the longitudinal direction.

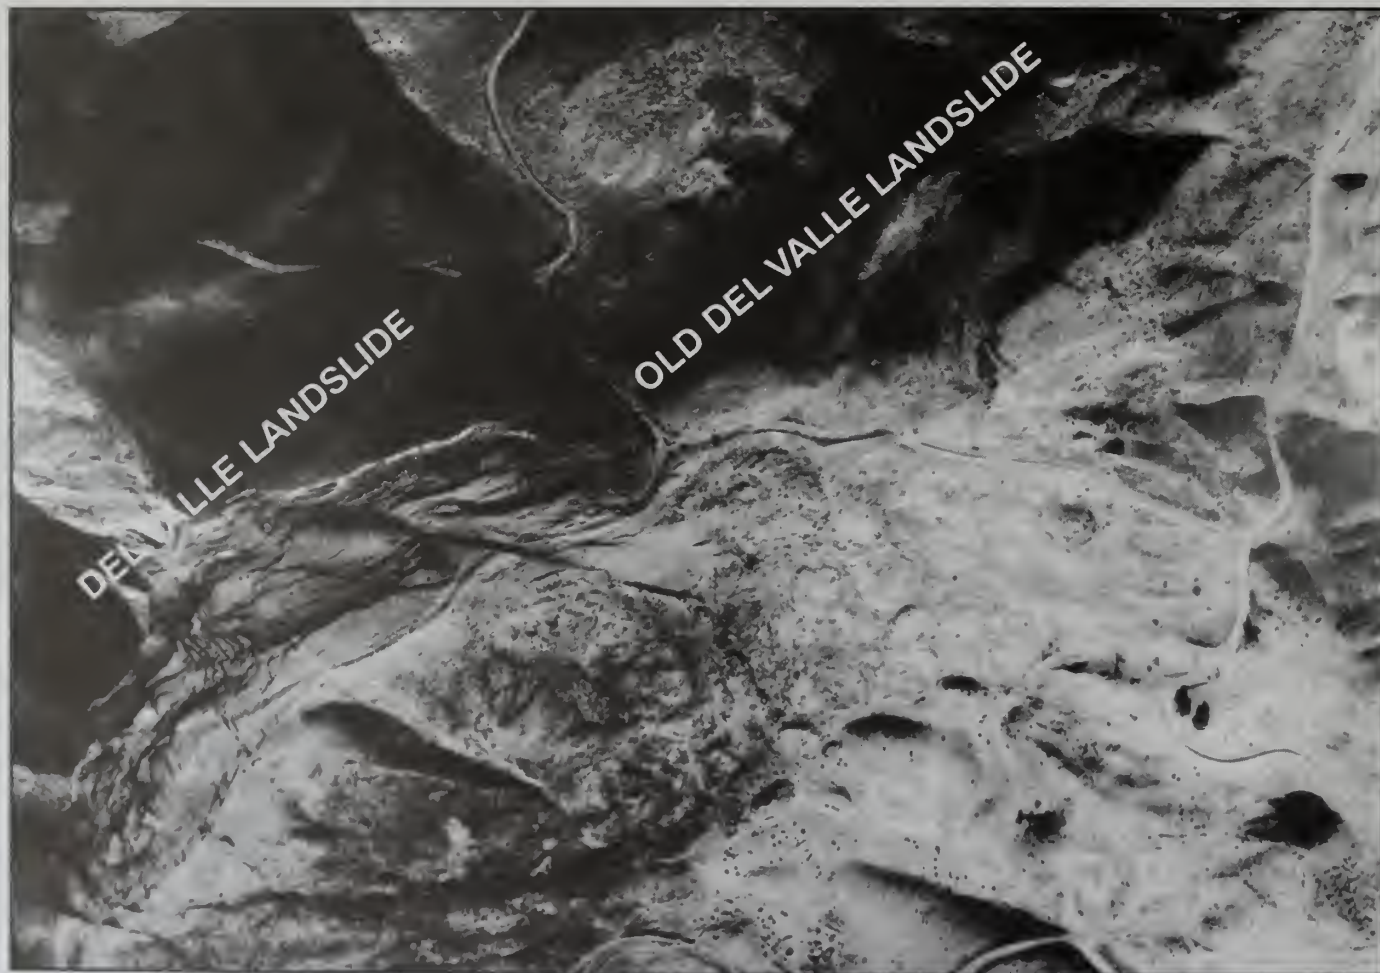
Photo 1. Enlarged U-2 photo of Del Valle and Old Del Valle landslides. Photo courtesy of USAF-Beale AFB, 9th ISS.

The top of the ridge failed during the formation of the Del Valle landslide and the main scarp extends into adjacent drainages to the north (Photo 1). The landslide mass moved to the south-southeast, with a series of uphill-facing minor scarps at a maximum distance of about 100 m to the south of the main scarp, forming a graben near the ridge top. The steeper slopes of the lower part of the landslide are hummocky, and show evidence of older shallow slope movement.

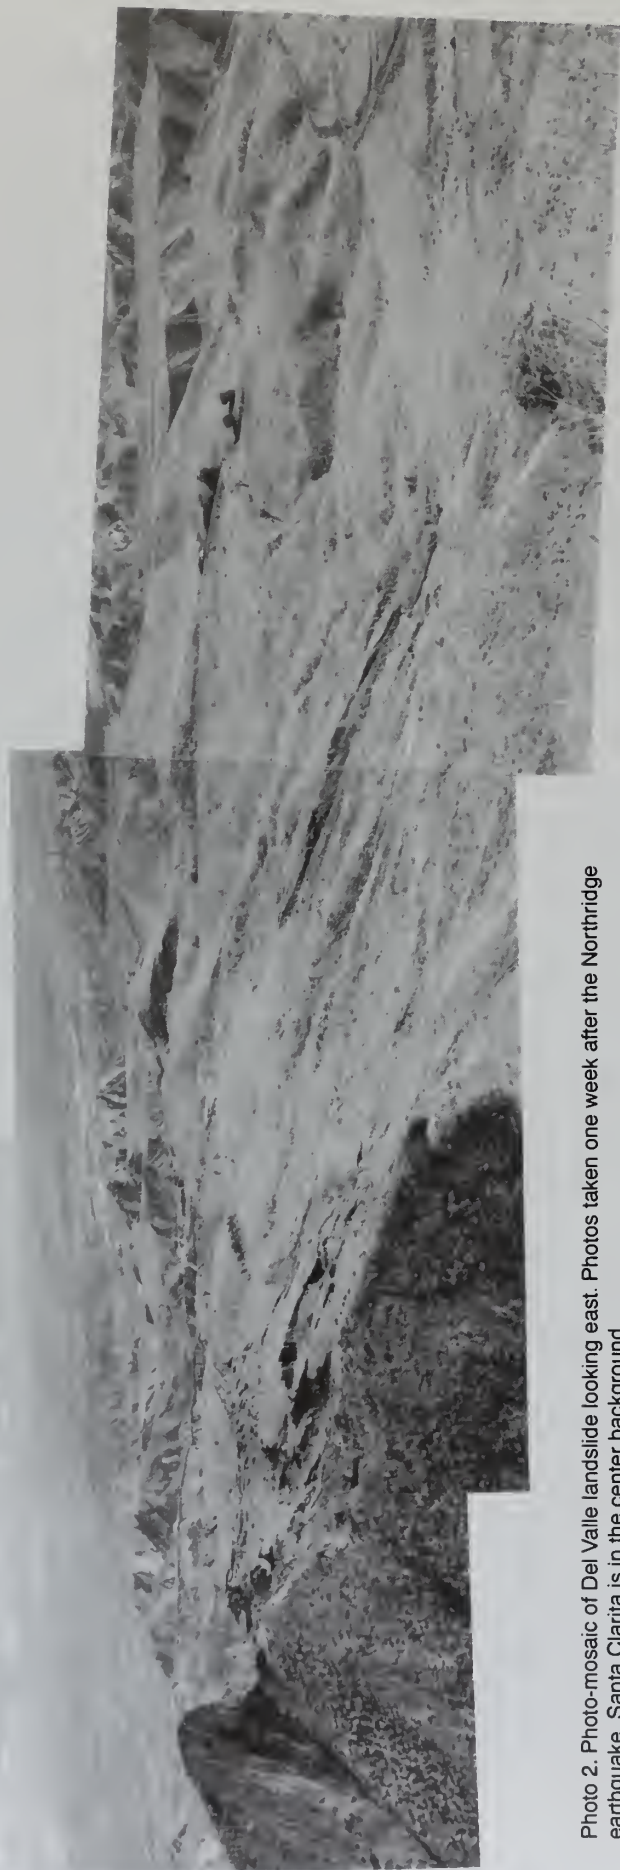
Photo 2. Photo-mosaic of Del Valle landslide looking east. Photos taken one week after the Northridge earthquake. Santa Clarita is in the center background.

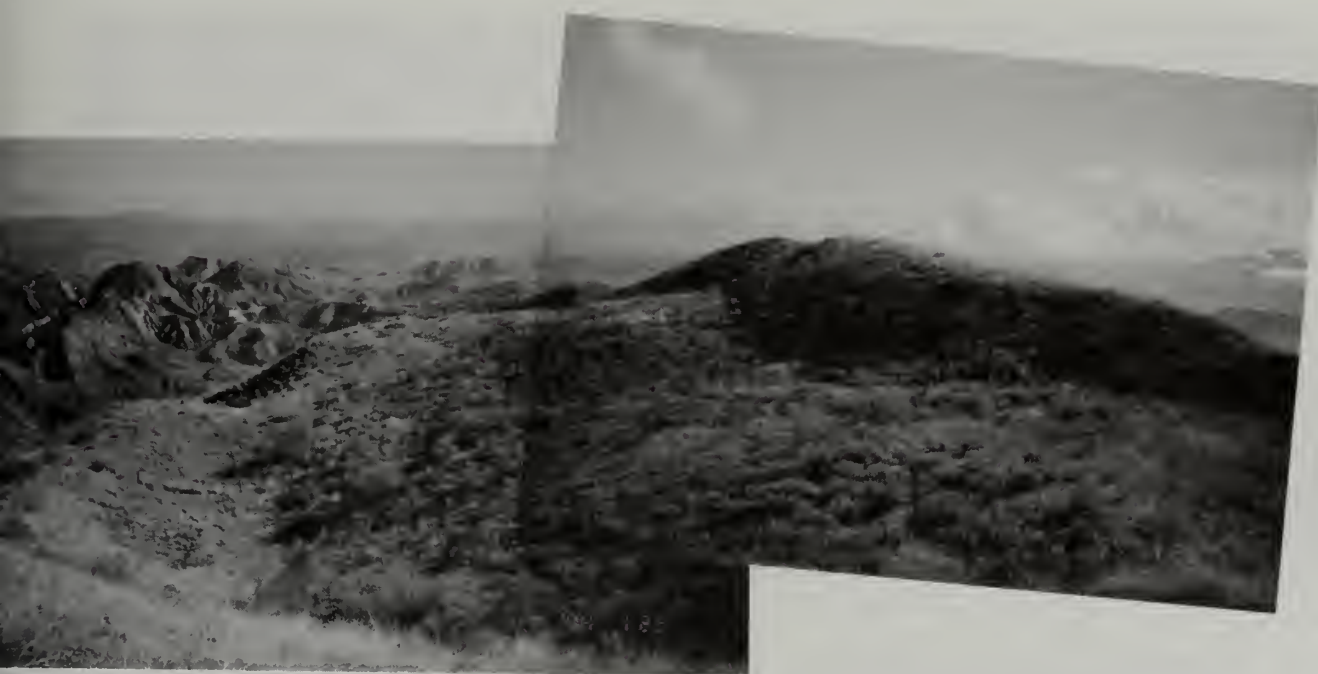
Photo 3. Photo-mosaic of the 'top' of the Old Del Valle landslide looking east. Landslide movement was to the right.

reactivated by it. In the field, it appeared that the landslide movement was to the north, opposite that of the Del Valle landslide (Photo 3). However, on 1:12,000 scale aerial photos taken by the NASA-Ames Research Center five days after the earthquake, it was observed that this older landslide clearly moved toward the south-southeast. Photo 4 is a stereo pair of both the Del Valle and the Old Del Valle landslides and the morphology and direction of movement for these two landslides can be observed.

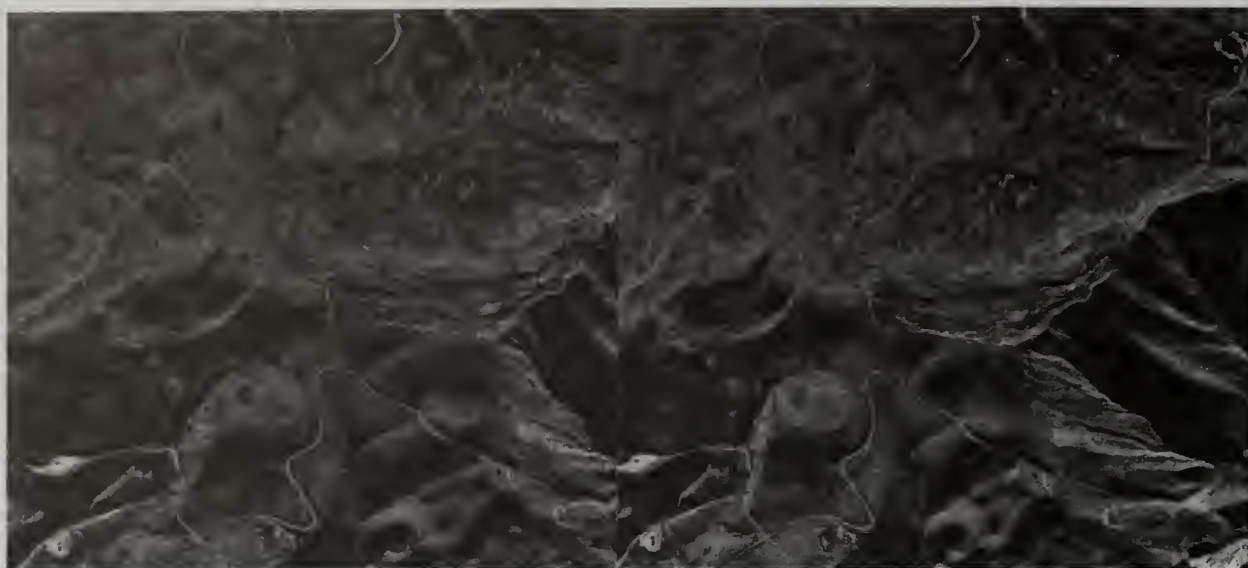
Recognizing the Del Valle landslide as an earthquake-triggered failure indicates that the potential for ridge-top failure needs to be considered in mapping landslide susceptibility for future earthquakes. Although this landslide occurred in an unpopulated area, it is likely that urban development within similar geologic conditions has occurred, or will occur, elsewhere in California.

Photo 4. Stereo pair air photos of the Del Valle and the Old Del Valle landslides, approximate scale 1:12,000. Photo courtesy of NASA-Ames Research Center, C-130 Program.

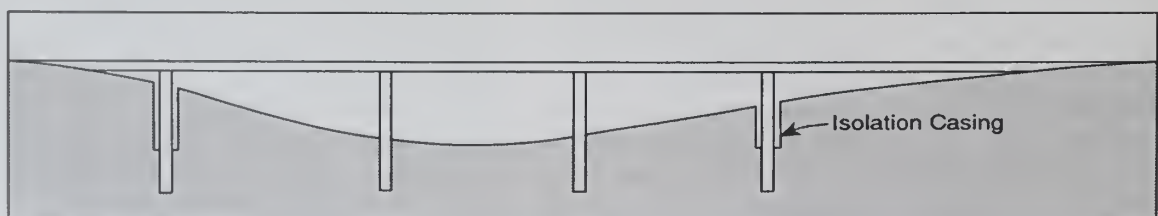
Figure 1. Maintaining constant column stiffness by using special 'isolation casings'.

the length and width of columns with drilled shaft foundations and using 'isolation casings' to give the columns more equal stiffness (Figure 1).

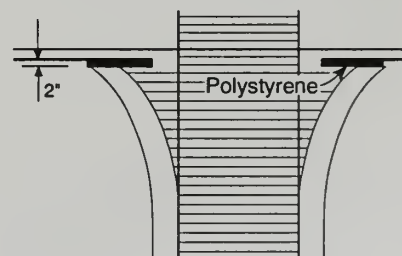
Column flares were an area of concern before the Northridge earthquake although no damage had at that time occurred due to flares. The problem was that engineers had long assumed that the flare was a non-structural element that would spall off during an earthquake. In reality, the flare was reducing the length of the column and increasing the plastic shear demand. A 2-inch gap between the soffit and the flare was one solution used to address these problems (Figure 3). However, testing at the University of California at San Diego showed that a 2-inch gap was too small and caused a high strain in the longitudinal steel. A three-prong approach is being used to address this problem. The first is to develop a simple procedure for designers to use to determine the plastic moment, shear, and hinge location for flared columns. This would require considering different plastic hinge locations on the flare. The plastic hinge will form at the location

Figure 3. Former column flare.

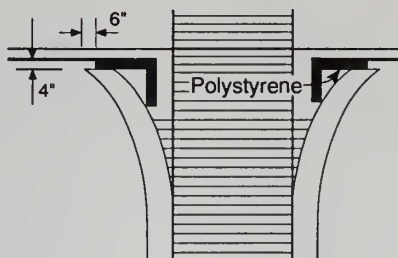
Figure 4. Improved column flare.

that results in the smallest plastic shear. A second approach is a research project to test different flared columns and validate their behavior. The third step is to come up with better flared column details. Figure 4 shows one proposed flare detail. A research project at the University of California at San Diego on Architectural Concrete and Bridge Columns is also developing architectural details that improve the seismic performance of columns. Alternatively, Caltrans architects are evaluating ornamental facades for bridges using nonstructural material that should not affect bridge behavior during earthquakes.

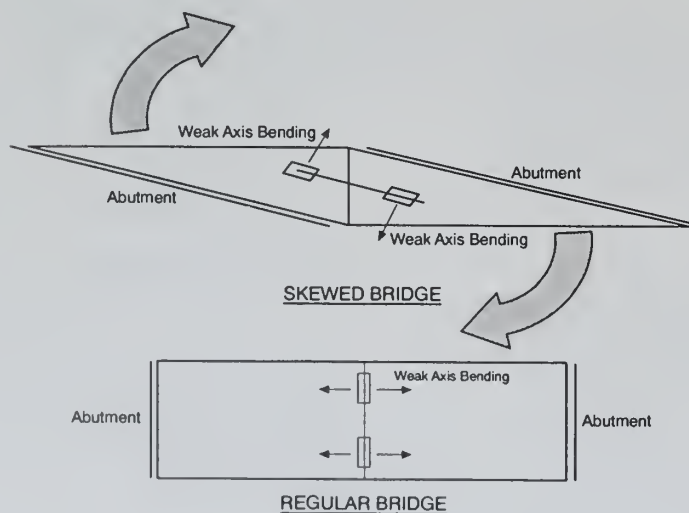
Highly skewed bridges can cause problems during earthquakes. Skewed bridges are extremely weak for one direction of rotation. In Figure 5, the abutments of the skewed bridge are very stiff in the counterclockwise direction but have very little stiffness in the clockwise direction. This clockwise rotation will cause the superstructure to slide out of its abutment seat. Also the columns of skewed bridges experience more biaxial bending during earthquakes. Finally, there is some question as to how effectively the current modeling procedure for bridges captures skew behavior. Possibly using *two* beam members or a grid to represent the superstructure would give more realistic displacements and forces for earthquake loads. This is the recommendation of the new load and resistance factor design of the American Association of State Highway and Transportation Officials Specifications currently under review. Certainly the partial collapse of the Gavin Canyon Bridges shows a need for better analysis techniques for skewed bridges. Whenever possible, skew should be eliminated or made as small as possible. Seat type abutments and hinges should

Figure 5. Skewed bridge behavior.

be avoided or provided with much larger seats for bridges with high skews. Bridges with abutment skews in opposite directions (Figure 6) like Mission Gothic Undercrossing should be avoided since they are extremely weak in one direction of movement.

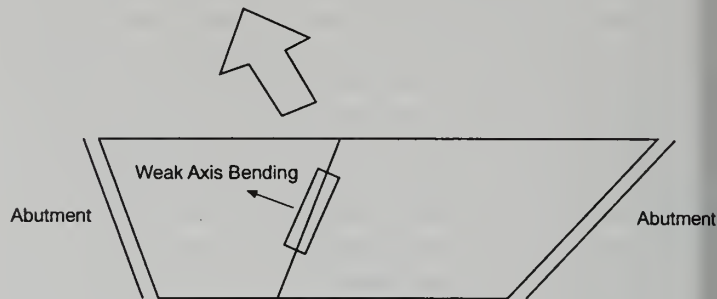
Figure 6. Weak direction movement of opposite skewed bridges.

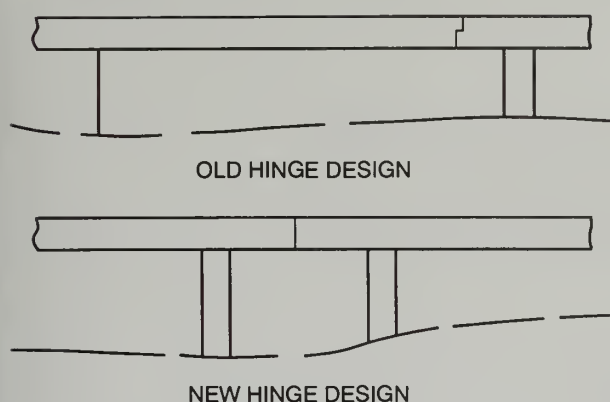
The phase 1 retrofit program began after the 1971 San Fernando earthquake to prevent large hinge movements with cable and rod restrainers. These retrofits had some success in controlling large movements during the Northridge earthquake. But the current hinge design makes it extremely difficult to make repairs and replace damaged bearings. Newer, more repairable hinge details are being developed. A new expansion joint design provides much better seismic response with no danger of unseating (Figure 7). This new design was used on a replacement bridge in the 5/14 Interchange. This hinge may be particularly appropriate at locations where large displacements are expected.

Figure 7. Old and new hinges

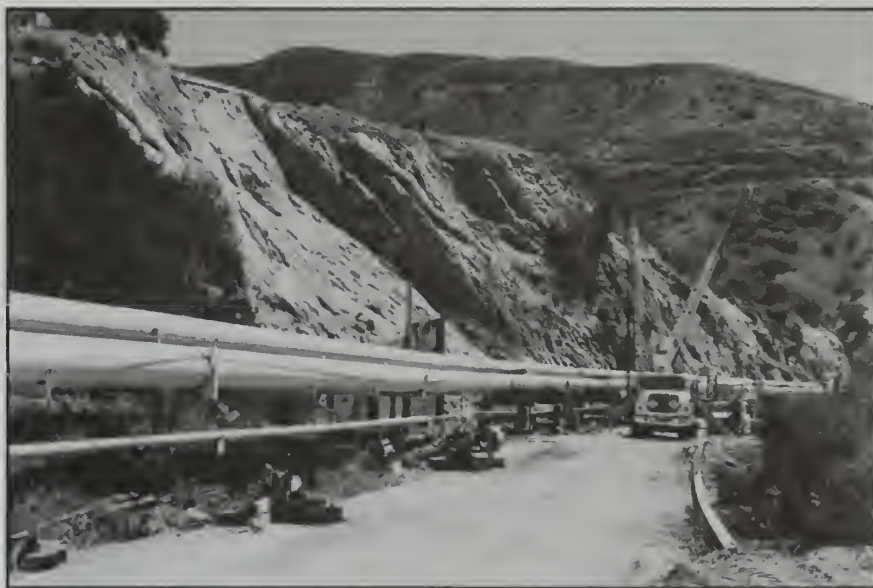
Photo 1. Landslide damage to pipelines at Aliso Canyon oil field from the Northridge earthquake. Photos by S.P. Mulqueen.

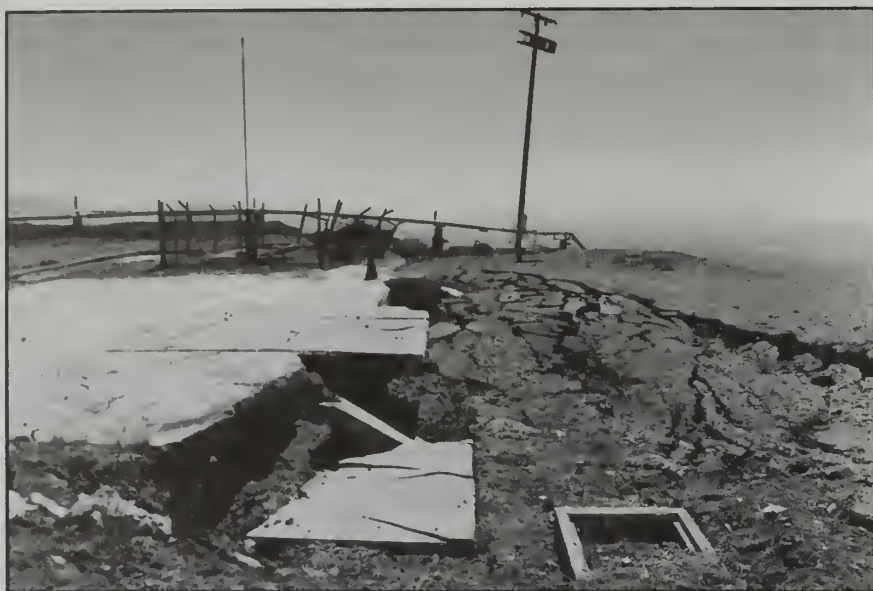
Photo 2. Surface damage to a well site in Aliso Canyon oil field from the Northridge earthquake.

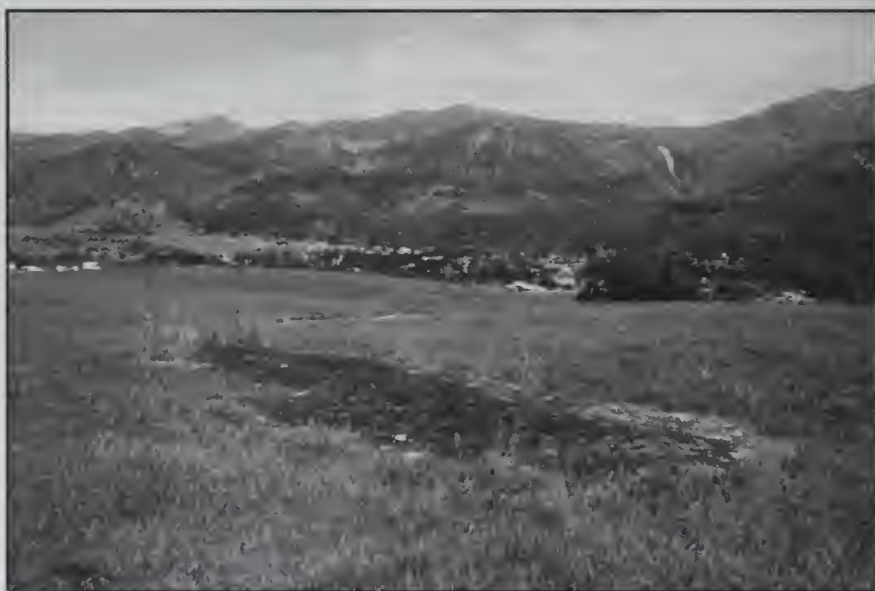
Increased natural seep activity was observed in Los Angeles, Ventura, and Santa Barbara Counties (Photo 3). New seeps have been reported in the Ojai and Newhall oil fields. However, this may not be an effect of the seismic activity, as seeps usually become more active in warmer and/or wetter weather.

Photo 3. A new oil seep appeared at Ojai field after the Northridge earthquake.
